Strip Map - SAFZ

SAN ANDREAS FAULT (PENINSULA) STRIP MAP DATA SHEET

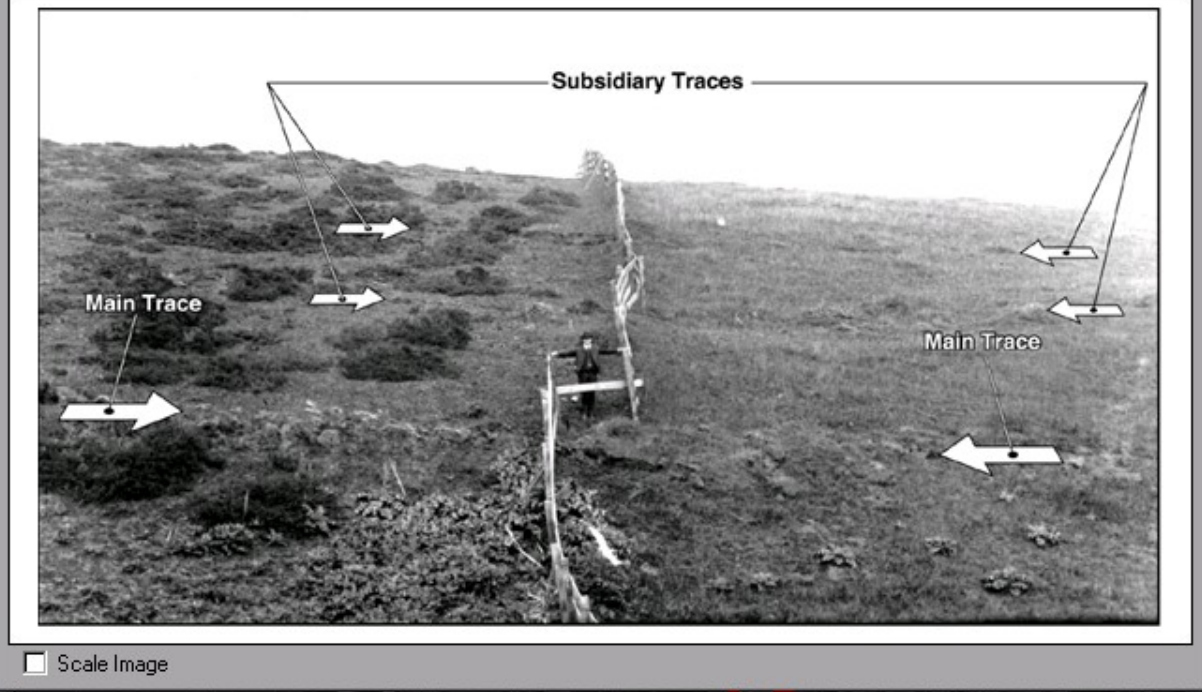
Photo No. SSF 27

Photo No. SSF27: Fence between sag ponds 8 and 9 dislocated by three traces active in 1906. View toward N68°E. Main trace by the person offsets the fence right-laterally about 2 meters. The two subsidiary traces located uphill to the northeast increase the net 1906 displacement an additional 0.6 to 1 meter. The same fence in 1956 is shown in Photo No. SSF31.

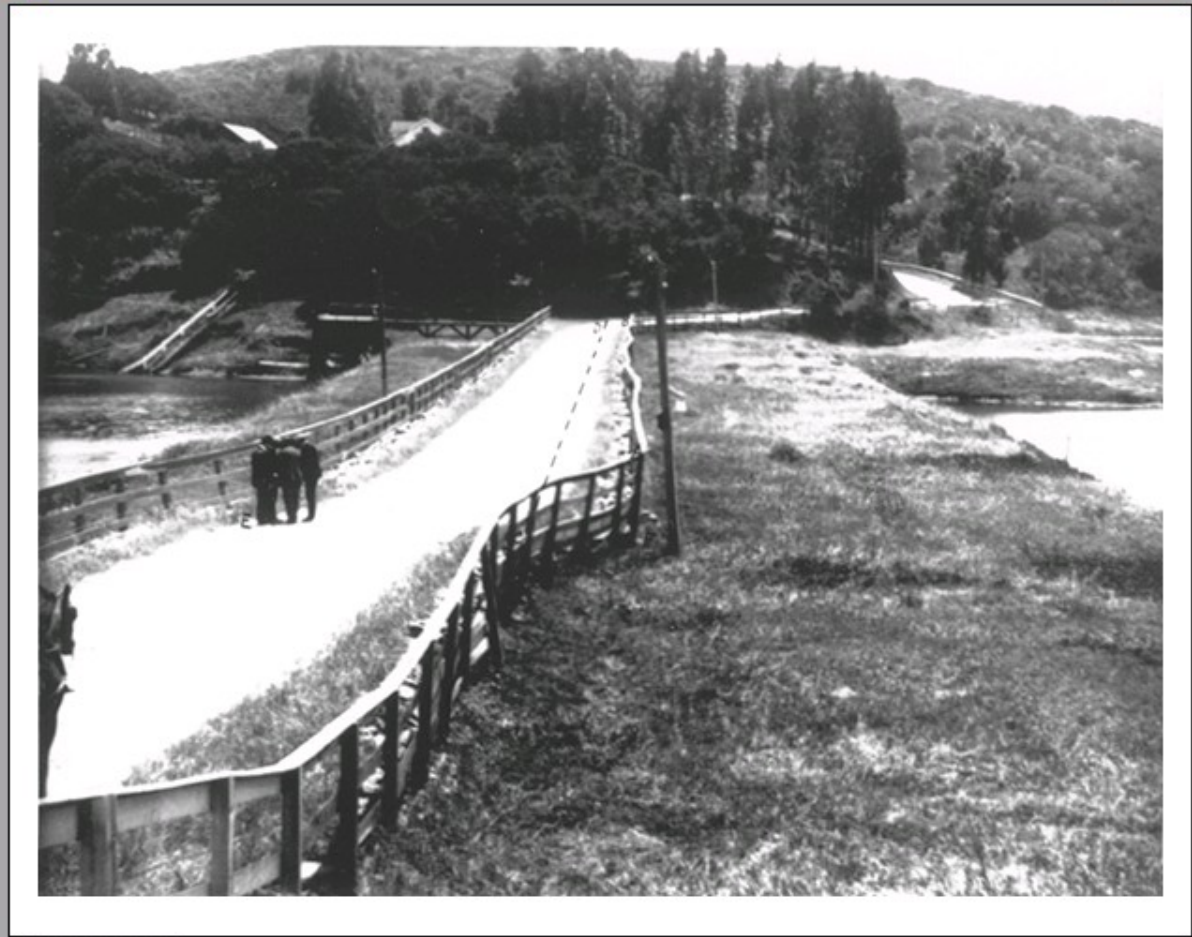
Photo No. SM 19

Photo No. SM19: View southwest along right-laterally offset fence. Both the road and the fence to the south of the road are also similarly offset. Note the dashed line in the roadway denoting the original position of the fence prior to faulting.

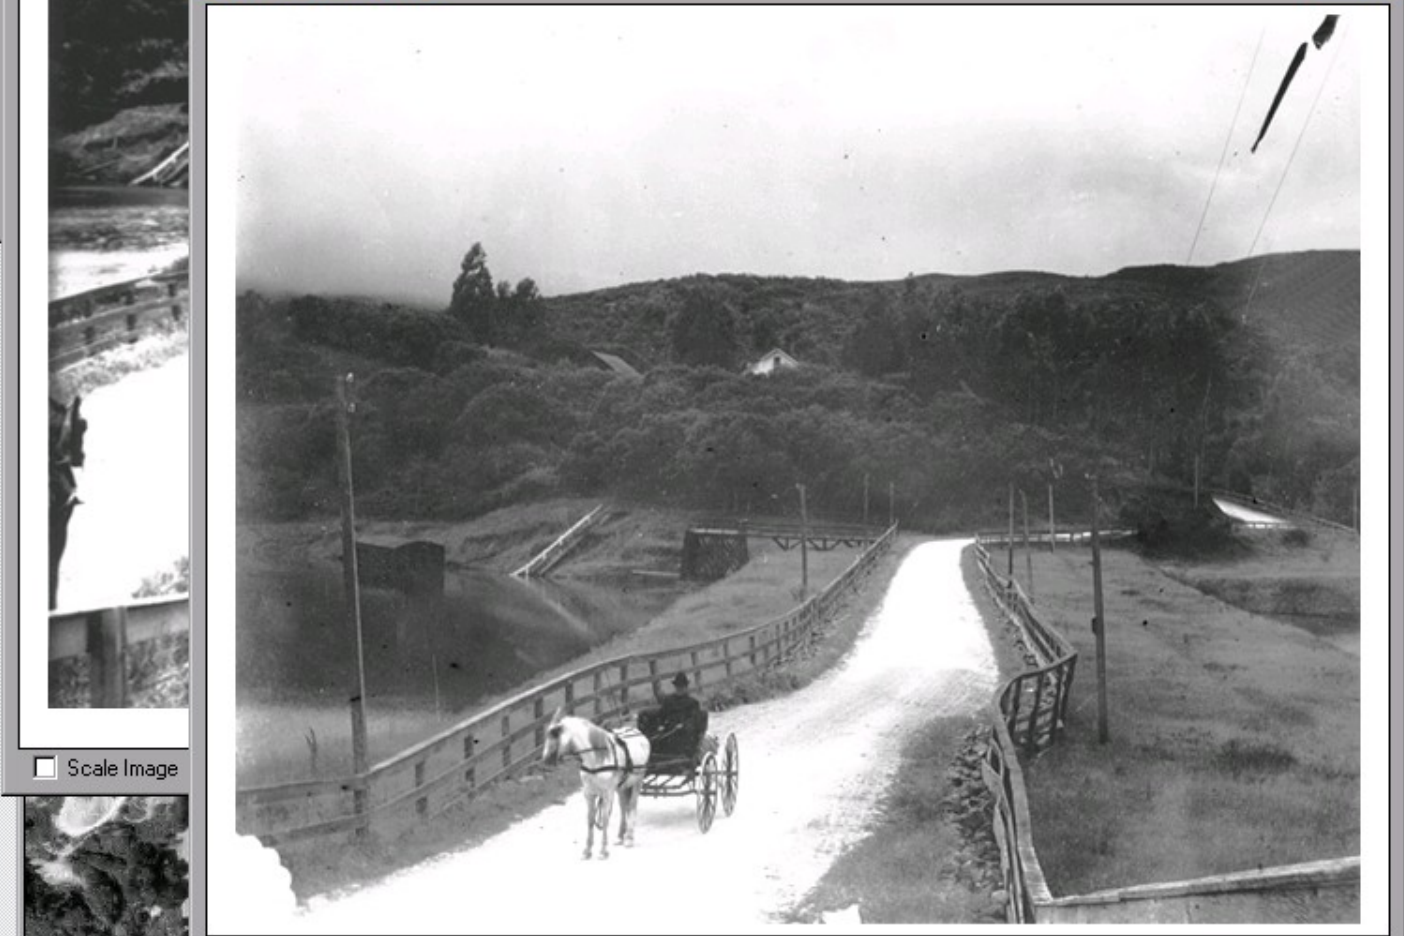
Photo No. SM 23

Photo No. SM23: Similar view as Photo No. SM19. Image taken from the opposite side of the fence. See Lawson, 1908, pp. 93-94, 101-102 for a more detailed description (Detailed Fault Description Number 5 and Number 9).
